TECHNICAL SERVICE BULLETIN

REFERENCE: SMU250KTST

SUBJECT: ALTERNATOR WHINE / PTT POPPING

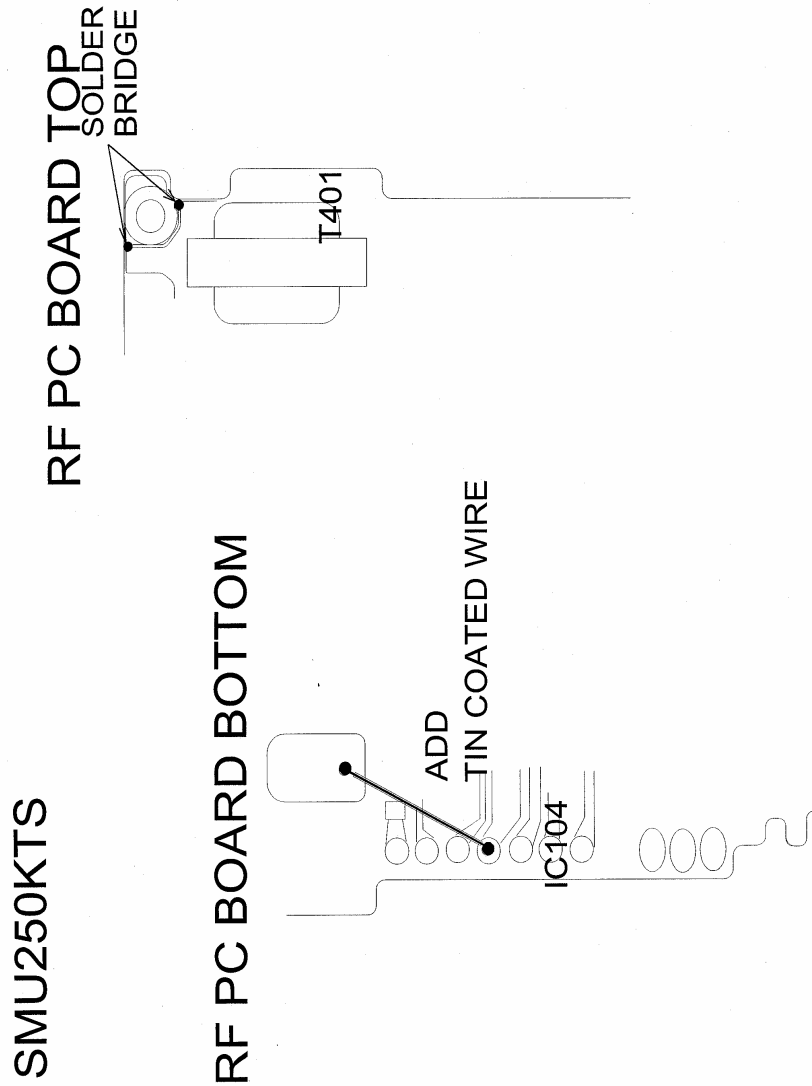
See page 2 for c and d locations.

GENERAL: This bulletin pertains to models with RF PCB version PD751AC, which is found in units with serial numbers 04xxxxxx and higher. Due to some of the changes in this new circuit board you may notice an increase in alternator noise, or popping during PTT. The following modifications can be made to improve operation.

- a. Change R168: 47 ohms to 150 ohms (BRFC011544Z)
- b. Change R133: 22K ohms to 15K ohms (BRFC011534Z)
- c. Add JUMPER WIRE between No.4 pin of IC104 and T401 CASE GND.
- d. Connect GND PATTERN near by T401 by soldering.
